Bulletin of the Mineral Research and Exploration

Investigation of the change in the characteristic properties of epoxy and silane coated natural stone surfaces

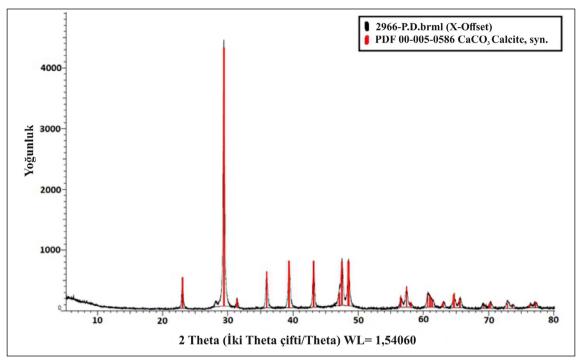
Figure 1- XRD analysis result.

The result of the X-ray diffractometry analysis of the untreated travertine sample is given in Figure 1. It was determined that the content of the sample was calcite in XRD analysis.

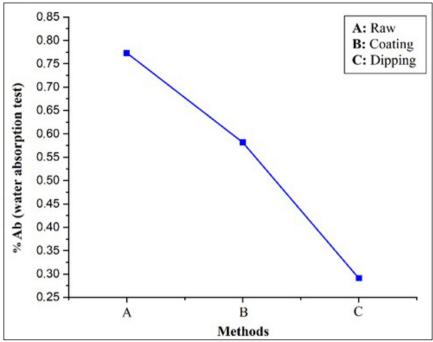
Figure 2- Water Absorption Test Results with Epoxy Applications.

evident in the water absorption value. For this reason, the change in water absorption values by using silane and epoxy chemicals on the sample was determined according to the TS EN 13755 standard. The raw sample was studied on travertines treated with epoxy and silane for the water absorption test. The results obtained in the water absorption test studies carried out in various parameters are given in Figures 2 and 3.

and epoxy effectively reduce the water absorption value. Under normal conditions, epoxy surface coating provides complete sealing and zero water absorption. However, as a result of this study, observing some water absorption in epoxy-coated samples is entirely related to the coating process. In other words, since the air bubbles in the epoxy resin were not removed in a vacuum environment before the coating process, they formed partial porosity during curing, which caused the sample to absorb a small amount of water.

The effectiveness of the dipping method was investigated after the application of impregnation with the application. As a result of immersing the samples in epoxy and silane for 10 minutes, water absorption values of 0.291 with a standard deviation of 0.05 in epoxy and 0.278 with a standard deviation of 0.20 in silane were obtained. In this study group, it was determined that the water absorption value of silane gave more effective results than epoxy. In the continuation of the study, the silane immersion time was changed to 20 and 40 minutes, and the results were examined. It was observed that the water absorption values of 0.240 with a standard deviation of 0.18 and 0.231 with a standard deviation of 0.22 respectively. were slightly better against immersion for 10 minutes, but these time changes were not very effective for the study.

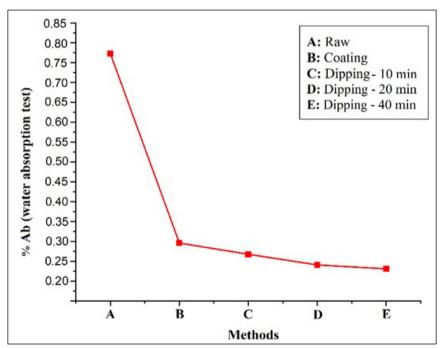
Figure 3- Water absorption test results with silane applications.

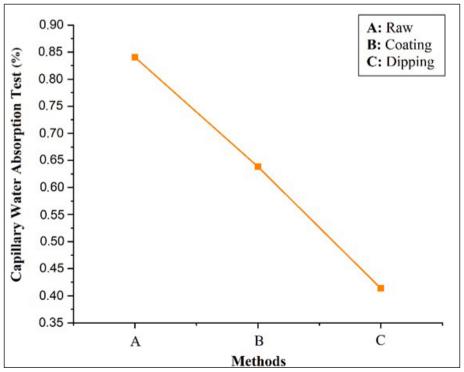
Figure 4- Capillary water absorption test results with epoxy applications.

with silane and epoxy with different methods were examined. The results are given in Figures 4 and 5.

When the capillary water absorption test results were examined, the capillary water absorption value of the raw sample was calculated as 0.841. While the capillary water absorption value of the epoxy was 0.648 with a standard deviation of 0.31 due to the application of rubbing on the surface, the capillary water absorption value of the silane obtained by the same method was 0.383 with a standard deviation of 0.22. When the values were examined, the capillary water absorption value of the raw sample was higher than those treated with epoxy and silane. On the other hand, the capillary water absorption value of silane was lower than epoxy. This shows that epoxy and silane effectively reduce the capillary water absorption value.

The effectiveness of the dipping method was investigated after the application of impregnation with the application. As a result of immersing the sample in epoxy and silane for 10 minutes, the capillary water absorption value was obtained as 0.414 with a standard deviation of 0.10 in epoxy and 0.295 with a standard

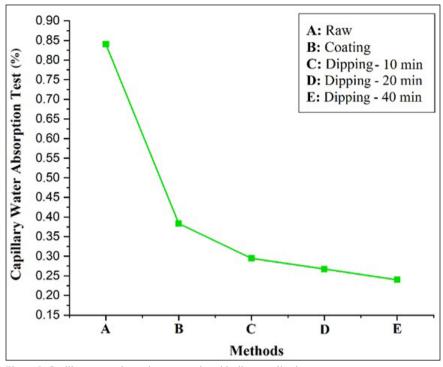
Figure 5- Capillary water absorption test results with silane applications.

deviation of 0.04 in silane. The study determined that the capillary water absorption values of silane were more effective than epoxy. Then, the silane immersion time was changed to 20 and 40 minutes, and the results were examined. However, although the results were slightly better than 10 minutes, it was determined that it was not very effective, with 0.268 with a standard deviation of 0.09 and 0.239 with a standard deviation of 0.17 for the study.

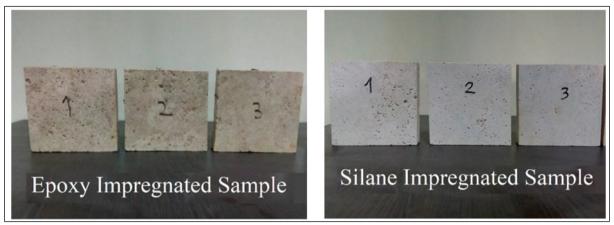
Figure 6- Pre-run image of a few of the samples dipped in epoxy and silane.

To define the resistance of the travertine samples to be used in the study against salt crystallization and to observe the effect of epoxy and silane on salt crystallization, Salt Crystallization Resistance Tests were carried out according to the TS EN 12370 standard. Figures 6, 7, and 8 show the samples

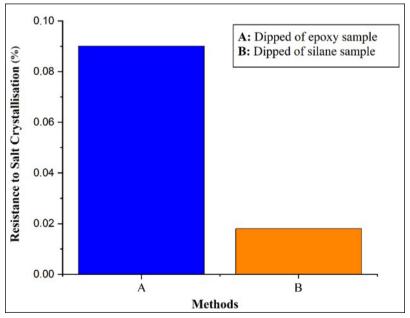
Figure 8- Results of determination of resistance to salt crystallization of epoxy and silane immersed samples.

By the determination of Resistance to Salt Crystallization of Epoxy and Silane, and it was determined that the Average Mass Change (%) of the sample kept in epoxy for 10 minutes was 0.090, the standard deviation was 0.119, the Average Mass Change (%) of the sample kept in silane for 10 minutes was 0.018 and the standard deviation value was 0.021. The results show that the silane-treated samples had higher resistance to salt crystallization. In addition, in the observations made on the samples after the experiment, no decomposition and crack formation were observed due to the exposure of the travertine samples to salt crystallization.

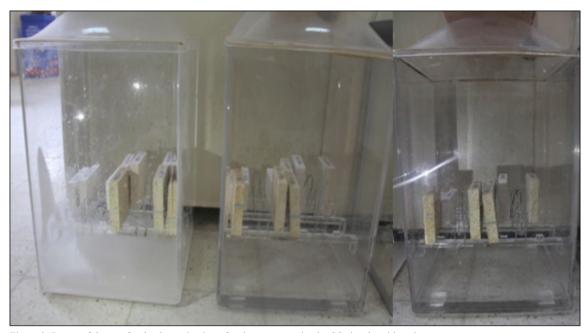
Figure 9- Image of the test for the determination of resistance to ageing by SO, in a humid environment.

Samples taken from the sample group, immersed in epoxy and silane for 10 minutes and then dried at room conditions, were used to determine the resistance to SO_2 attrition in a humid environment. The study was carried out according to the TS EN 13919 standard in 2022. A visual of the experiment process is given in Figure 9. In Figure 10, the results obtained from the experiments are given.

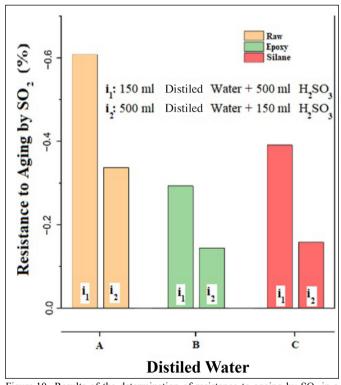
Figure 10- Results of the determination of resistance to ageing by SO₂ in a humid environment of raw, epoxy and silane immersed samples.

On the raw sample in the resistance to ageing by SO_2 in a humid environment test, the Average Mass Change (%) in the mixture formed with 150 ml distilled water + 500 ml H_2SO_3 was -0.608, and the

In the study carried out with epoxy and silane for the determination of the resistance to SO₂ attrition in a humid environment, the sample, which was kept in epoxy for 10 minutes, was found in a mixture of 150 ml distilled water + 500 ml H₂SO₂ and the Average Mass Change (%) was -0.293. The standard deviation value was 0.049 in 500 ml of distilled water. In the mixture formed with water + 150 ml H₂SO₂, the Average Mass Change (%) was found to be -0.144, and the standard deviation value was 0.182. The Average Mass Change (%) of the sample, which was kept in silane for 10 minutes, was -0.391, and the standard deviation value was 0.138 in the mixture formed with 150 ml distilled water + 500 ml H₂SO₂, and the Average Mass Change (%) in the mixture formed with 500 ml distilled water + 150 ml H₂SO₃ was found to be -0.391. It was determined that the standard deviation value was -0.158 and 0.159.

It has been seen by the Determination of Resistance to SO₂ Attrition in Humid Environment that the epoxytreated samples gave more durable results than the silane-treated samples. This shows that epoxy-treated
